Phase I Inspection Report
Mud Lock C&S Canal Dam
Oswego River Basin, Cayuga County, NY
Inventory No 416

14 September 1981

PHASE I INSPECTION REPORT
NATIONAL DAM SAFETY PROGRAM
MUD LOCK C&S CANAL DAM
I.D. NO. NY 416
64A-369
OSWEGO RIVER BASIN
CAYUGA COUNTY, NEW YORK

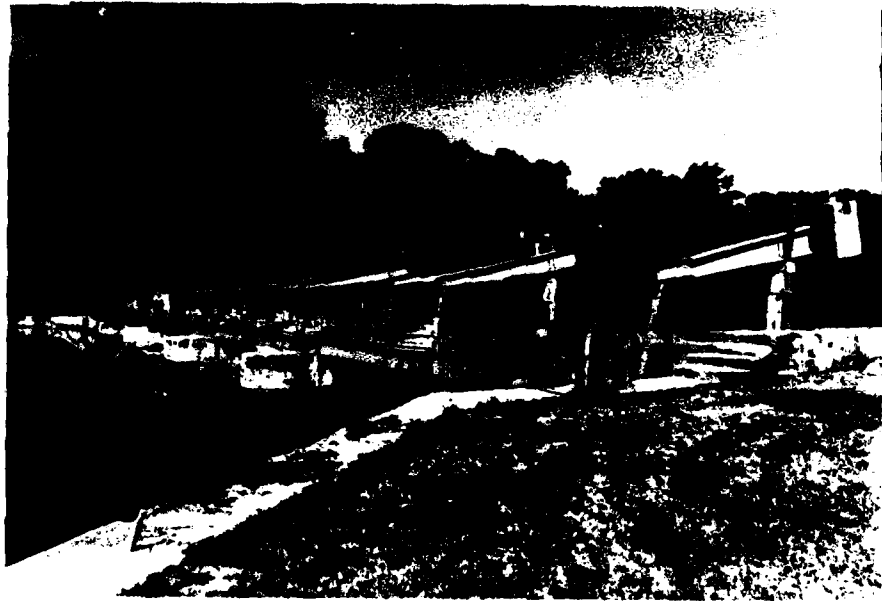
UPSTREAM VIEW OF DAM

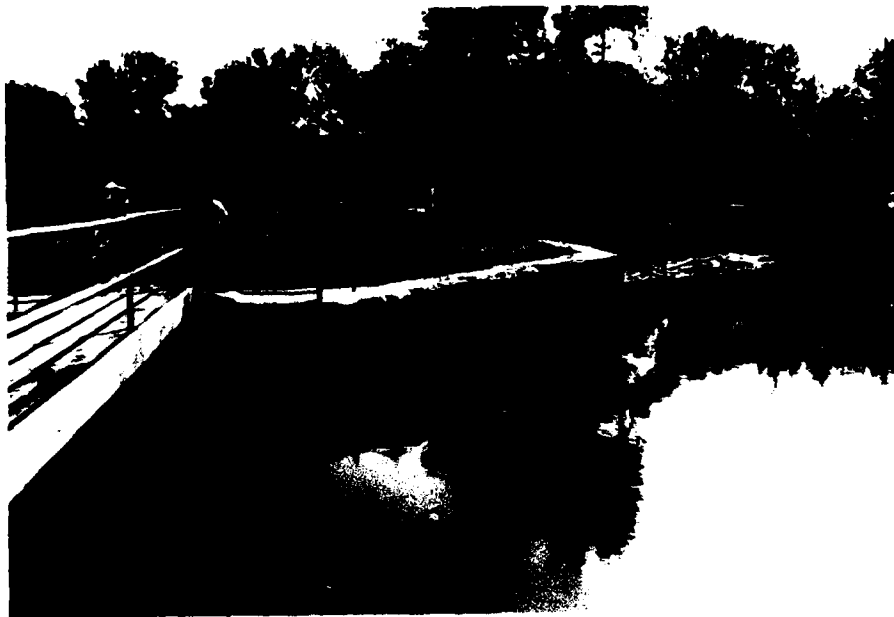
The grass cover on the right embankment was recently cut, which facilitated inspection of this side of the dam. The crest is relatively flat, with no apparent irregularities on the surface. Minor soil erosion due to runoff was noted behind the upstream retaining wall of the right abutment. Some vegetation is growing on the riprap slopes upstream and downstream of the retaining walls.

UPSTREAM RETAINING WALL AND RIGHT ABUTMENT

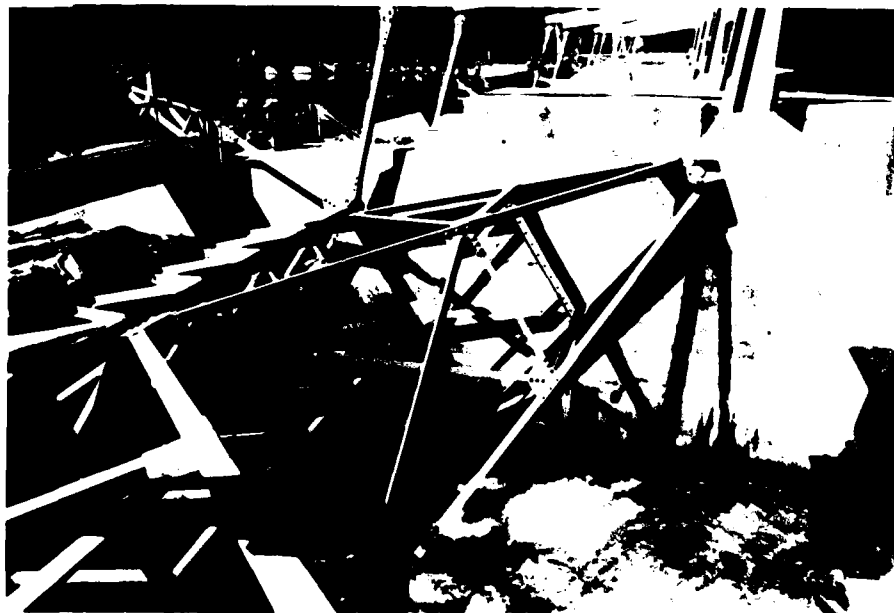
At the time of the inspection, two of the six taintor gates were slightly open to permit a minimum flow of 200 cfs into the Seneca River. Heavy leakage was occurring around the end seals of three of the gates.

TAINTOR GATE (OPENED APPROXIMATELY 3 INCHES)

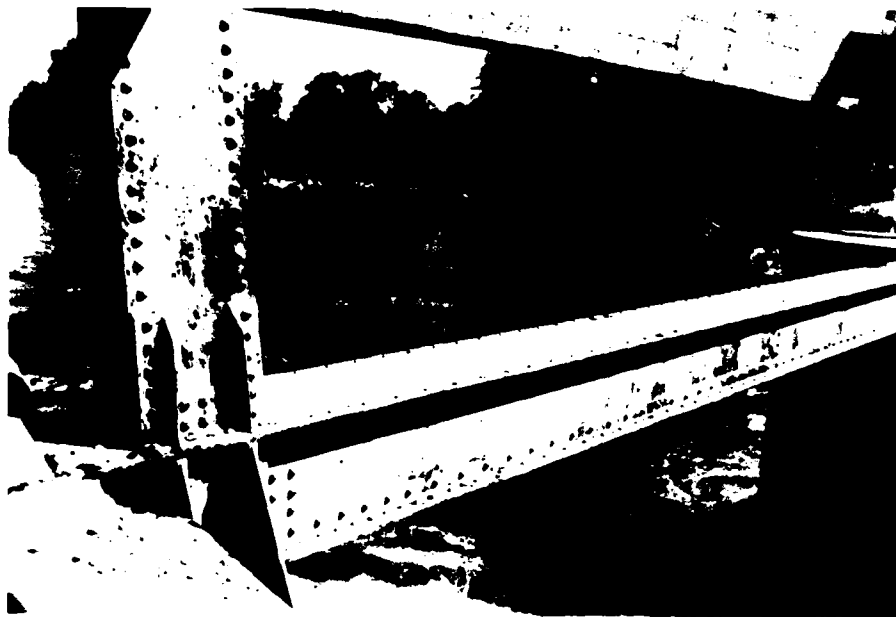
RUST ON COLUMNS AND BEAMS

- a. Cracks and spalling on the visible portions of the concrete retaining walls, piers, and counterweights should also be repaired.
- b. All steel work on the superstructure should be sandblasted, primed and repainted where necessary, to prevent continued rusting and pitting.

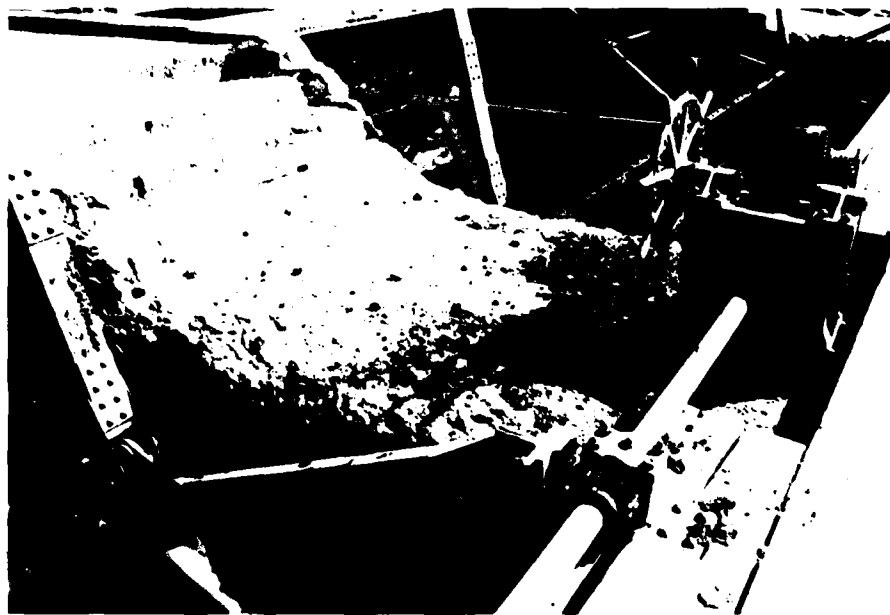
The spillway is in fair to poor condition, with the major deficiency being the deterioration of the concrete piers. Heavy spalling occurs on the tops of the piers, particularly toward the center of the spillway and at the gate bearing points. Efflorescence was noted through horizontal fractures in the sides of the piers, with minor amounts of vegetation growing in the cracks. The lower two-thirds of the piers, and the sill, could not be inspected due to the tailwater elevation. The submerged portion of the piers and sill was reportedly inspected in 1973 by towing a cofferdam barge upstream of the spillway and thereby cutting off the flow. Substantial leakage beneath the sill was reported in the 1973 Condition Report, which is included in Appendix E.

SPALLING ON CONCRETE PIER
